REPLACING A GRAPHITE GASKET

Material to Survive an Extreme Environment

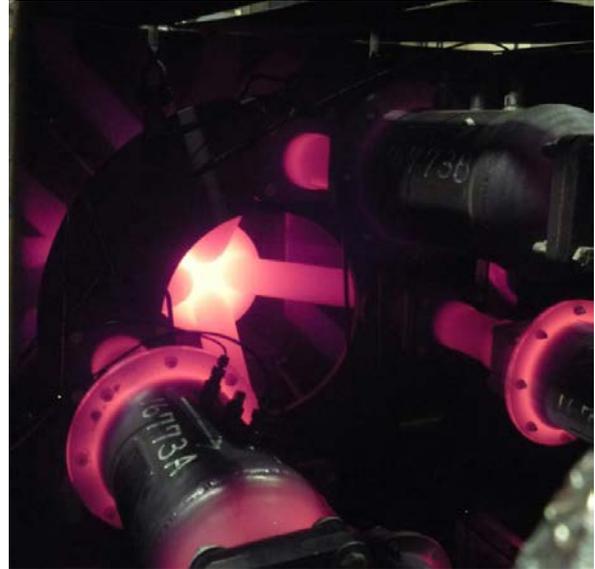
Red hot flanges found in test rigs.

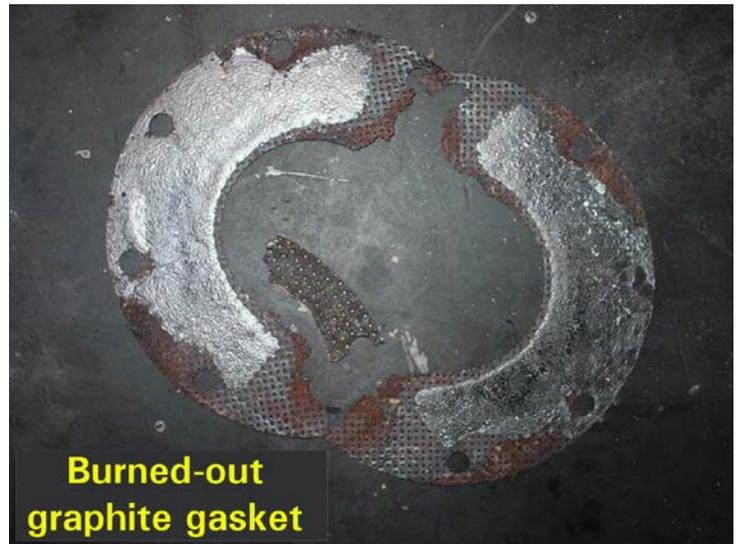
A gasket that failed the test cycle.

Initially, the customer was using a traditional graphite gasket for these exhaust flanges. The graphite was showing oxidation and deterioration due to the extreme conditions.
